PROGRESS REPORT PHOTOS

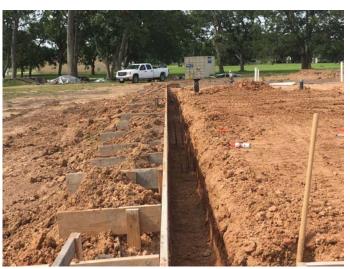
2. Excavation of grade beams for slab on grade
