PROGRESS REPORT PHOTOS

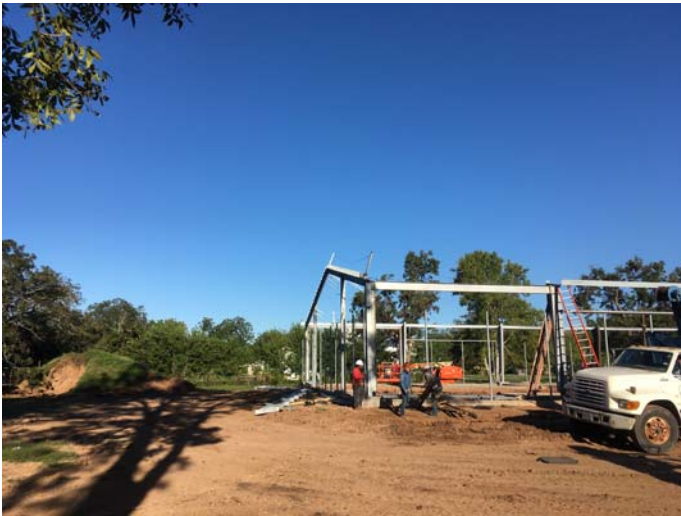
1. Erection of PEMB frame

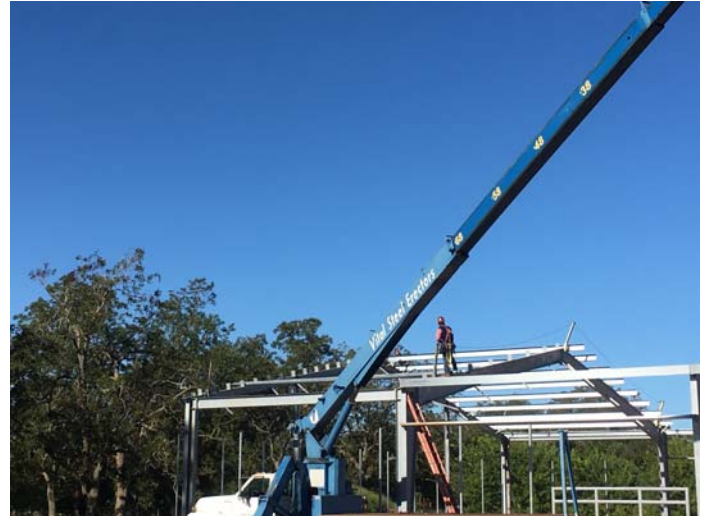
2. Erection of PEMB frame

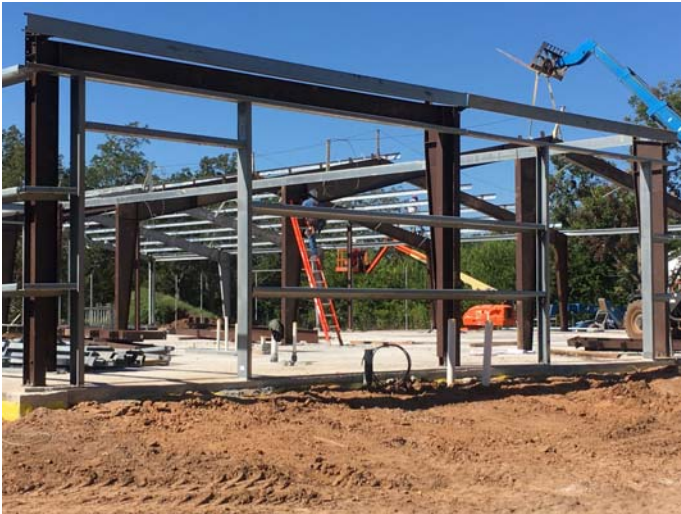
3. Erection of PEMB frame

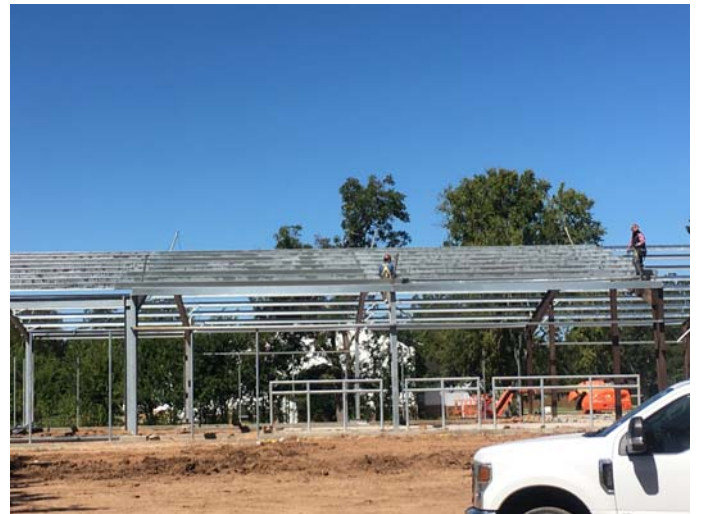
4. Erection of PEMB roof framing

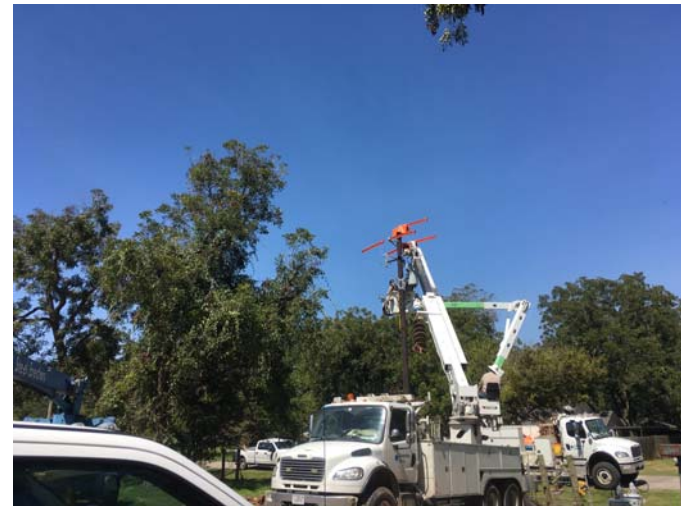
5. Installation of electrical provider service pole

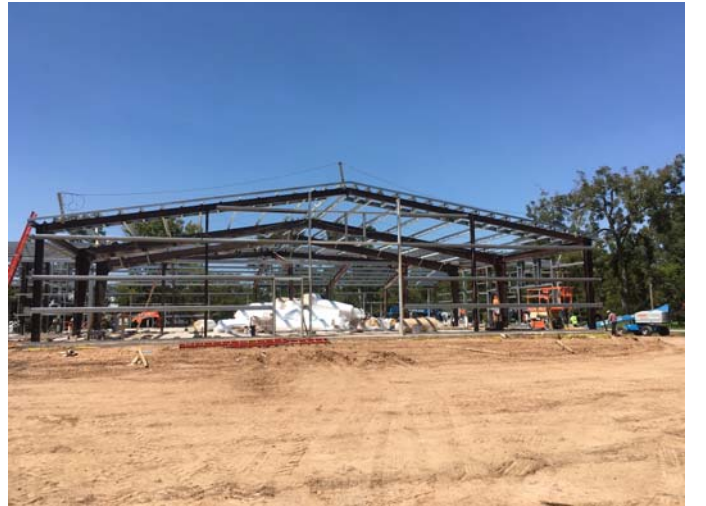
6. PEMB frame

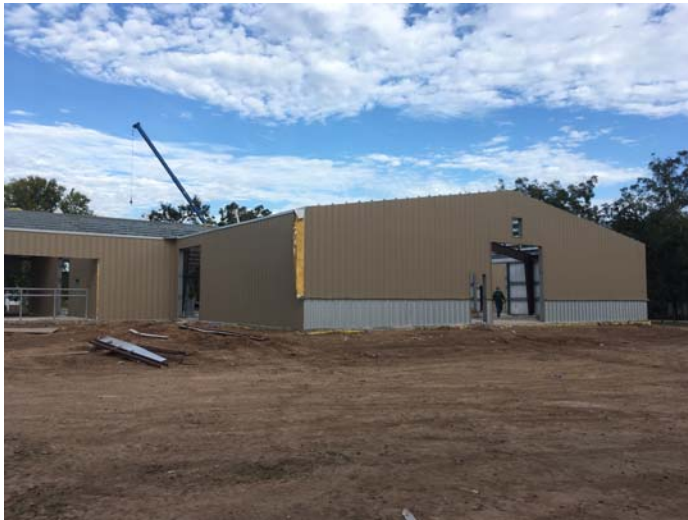
7. *Installation of PEMP wall sheathing*

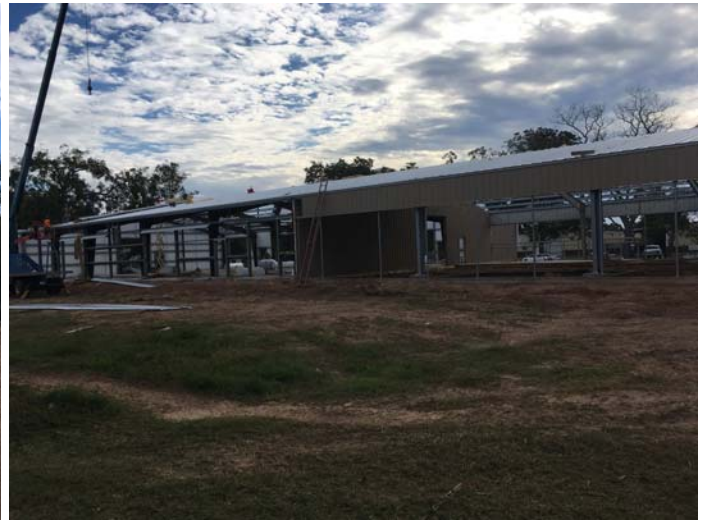
8. *Installation of PEMB roof sheathing*

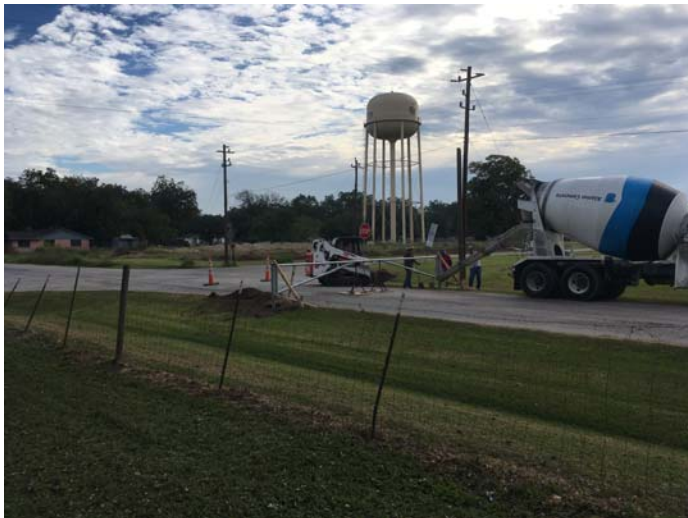
9. *Installation of security gates at abandoned R.O.W.*
